Fairview Beach Watershed Plan

King George County, Virginia

Prepared by
Interstate Commission on the Potomac River Basin (ICPRB)
30 W. Gude, Suite 450
Rockville, MD 20850

September 2014

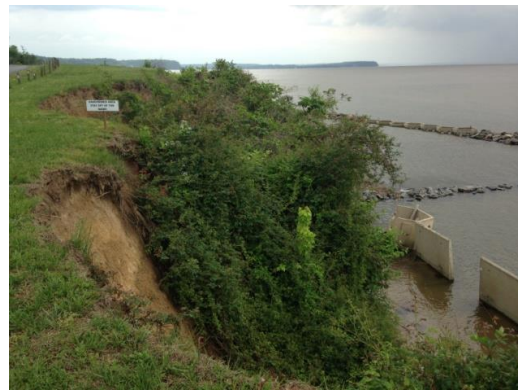
Figure 5-1. Locations of existing BMPs in the Fairview Beach plan area.

Beach erosion structures.

A number of management measures are already implemented in the plan area including BMPs for pet waste, beach erosion control, and education (**Figure 5-1**).

Stormwater BMPs have also been successfully installed in the plan area (**Figure 5-1**). The King George County Comprehensive Plan (King George County 2013) requires stormwater BMPs to be installed on properties with greater than 16% impervious cover, a CBPA Overlay Zoning District threshold. To date, 36 stormwater BMPs have been installed in the Lower Fairview Beach sub-watershed and 13 in the Lower Potomac Landing watershed. Measures installed in the Lower Fairview Beach sub-watershed include bioretention, dry wells, infiltration BMPs, and planted trees. Dry wells and infiltration BMPs were installed in the Potomac Landing sub-watershed. Load reductions associated with existing stormwater BMPs are provided in **Section 5.4.1**.

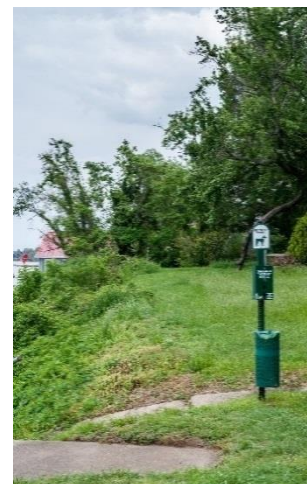
Fairview Beach pet waste station

Ongoing operation and maintenance of the ten existing pet waste stations will be an essential component of addressing this problem. Additional locations may also be warranted. Guidance on the operation and maintenance of pet waste stations is available from TCCSWCD, ICPRB, and commercial pet waste collection services.

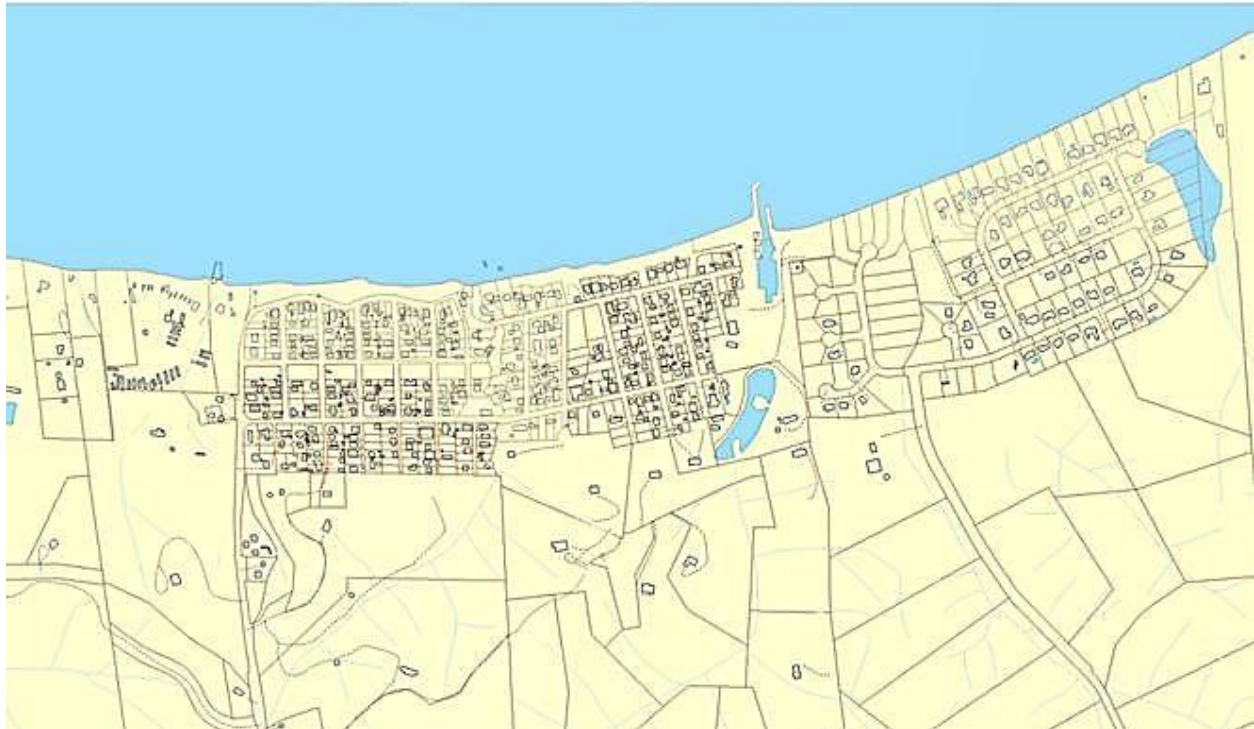
Figure 5-5. Parcels, buildings, and driveways. Parcel polygons are outlined in brown. Buildings are displayed as polygons with black boundaries. Hashed lines represent the driveways. This view was captured on the county's online GIS data viewer, 6/12/2014.

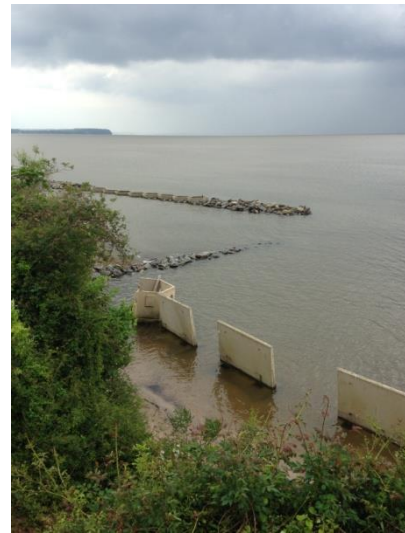
Existing beach management measures.
